Fire on left engine during start-up

Aircraft	ATR 72-212A registered F-OIQO
Date and time	18 November 2011 at 17 h 20 ⁽¹⁾
Operator	Air Tahiti
Place	Moorea airport (French Polynesia)
Type of flight	Scheduled public transport of passengers
Flight crew	Captain (PF) Copilot (PNF)
Consequences and damage	Left engine slightly damaged

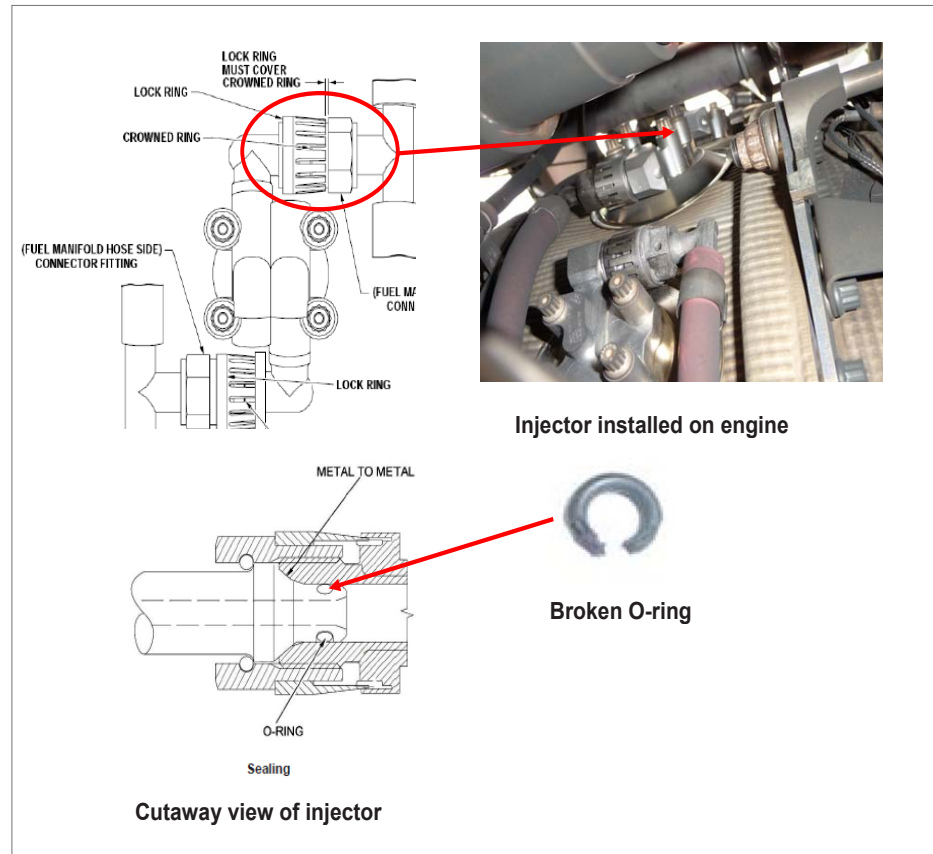
Examination of the engine showed that the cause of the fire was a fuel leak at the level of the manifold at injector n°14. Removal of the manifold showed that one of the two O-rings was cut (see photo and cutaway on following page).

Sealing between the injector and the manifold is ensured by tightening, metal against metal, to a torque level defined by the manufacturer. The two O-rings create an additional safety when this tightening is not correct. Any damage to them can lead to a leak.

The incident was the result of an inadequate maintenance operation. Incorrect tightening left a leak at the level of the metal to metal contact and led to a fuel leak at the level of the n°14 injector when the O-ring was damaged.

Following a study undertaken with two operators from July 2011, Pratt and Whitney Canada published, in February 2012, service bulletin SB 21803 R4. This bulletin is intended:

- to remove the O-ring ;
- to allow a leakage check on the metal to metal contact;
- to clarify the installation of the injectors and the procedures for checking for any leaks;
- to add a new procedure for leakage checks with nitrogen.

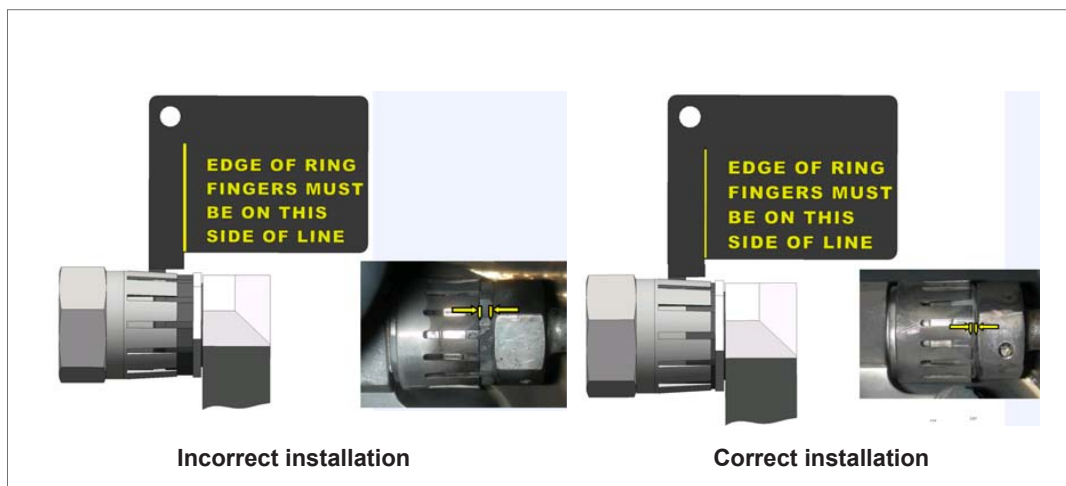
The leaks mainly appeared on the injectors located at the top and at the bottom (injectors 14 and 7) of the chamber. These are more difficult to access when the engine is installed in the nacelle and the maintenance mechanic can have difficulties in applying the correct tightening torque.

- publications and revisions of service information letters aimed at operators, in order to improve awareness of the risks run following an error in tightening the injectors,
- introduction of an indicator that makes it possible to check the correct level of tightening: (revision of the engine maintenance manual in June and August 2009).
